2008 MIDWEST LEVEE FAILURES: EROSION STUDIES

A Thesis

2008 Midwest Levee Failures: Erosion Studies. (December 2009)

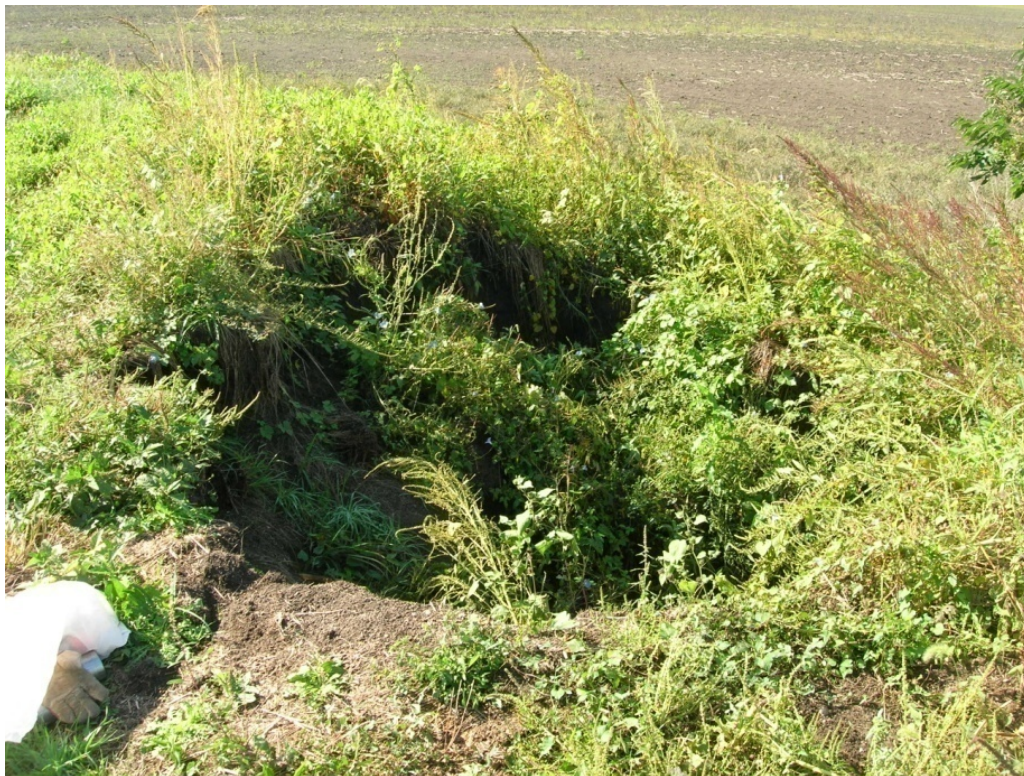
Fig. 121. Brevator levee seepage area at box culvert

This site was unique in the fact that there was no actual breach. A local resident (Mr. James Pieper) informed the team that the levee was overtopped by over half a meter of water for three days and never failed. The only sign of erosion was at a box culvert that was cracked allowing water and soil to seep through. Fig. 121 shows this seepage area.

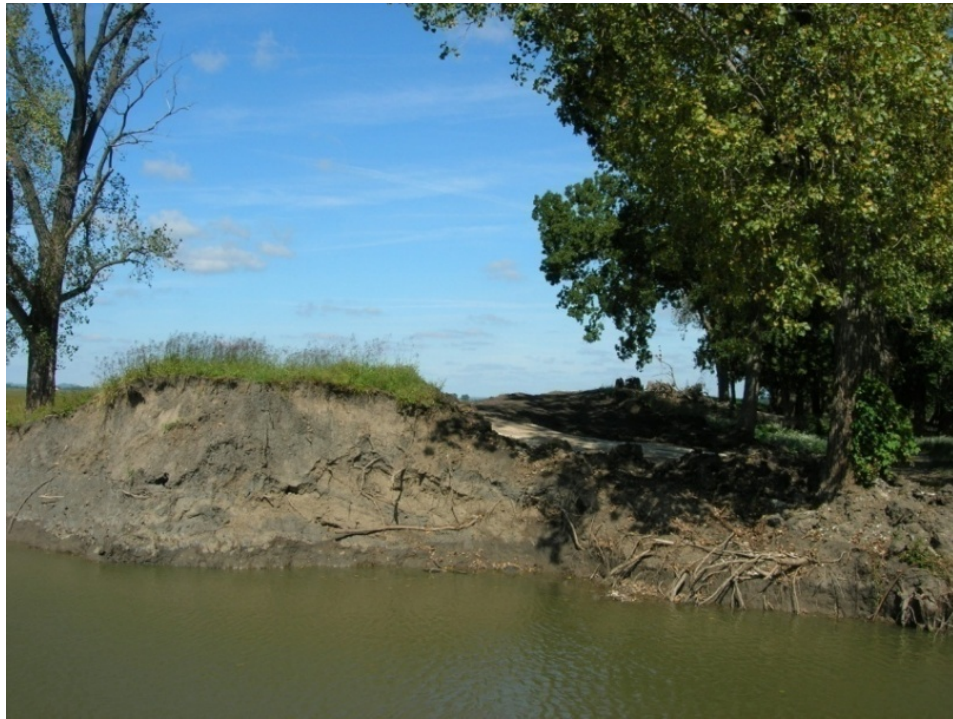
Fig. 124. Kickapoo north end of breach

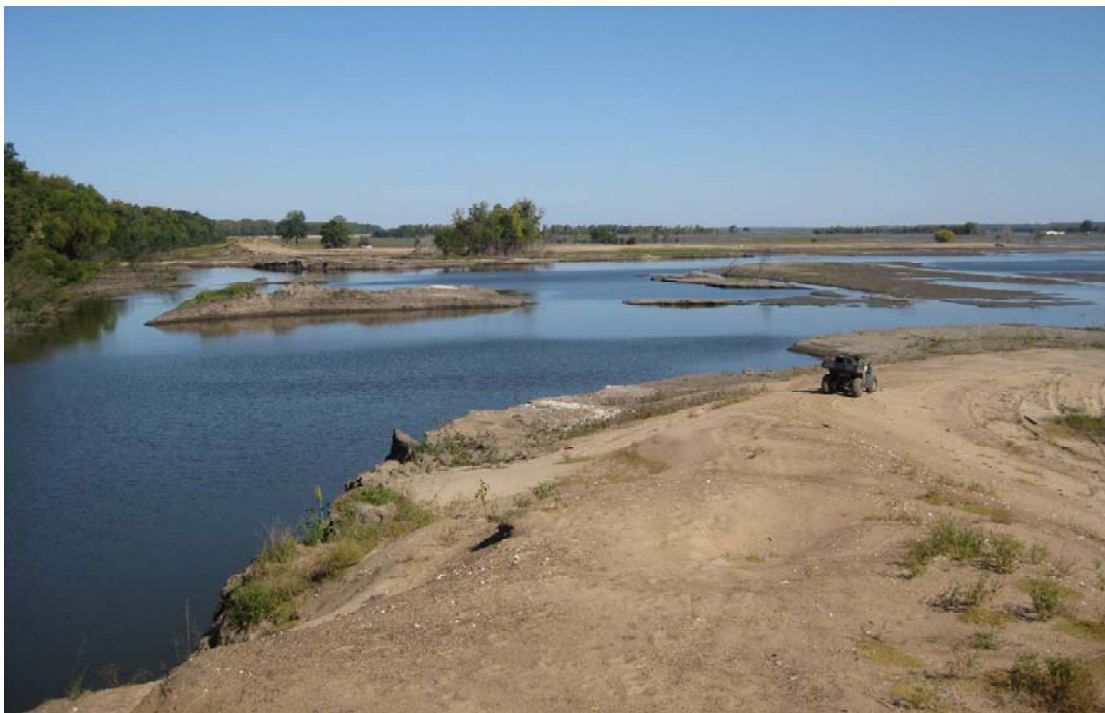
Fig. 137. Indian Graves Main breach – South side of breach looking North

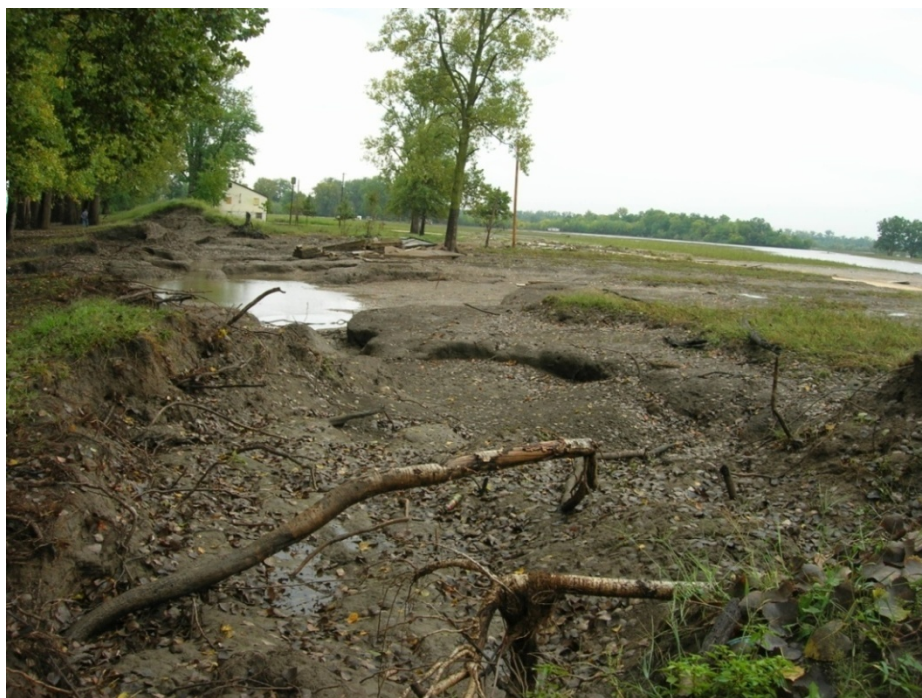
Tree roots shown in the missing levee section.

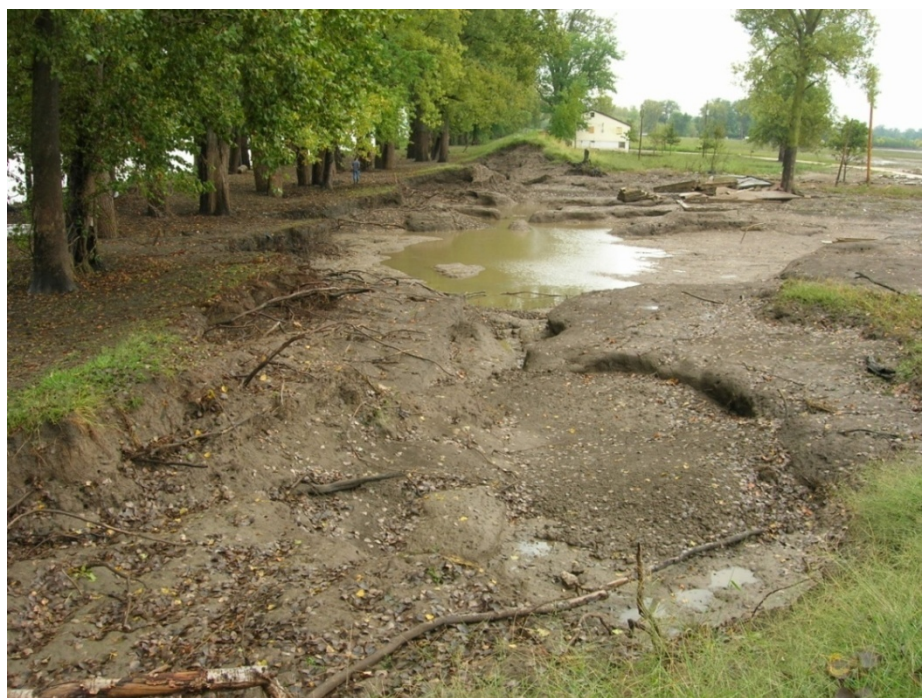
Tree roots and scour pool at Winfield breach.

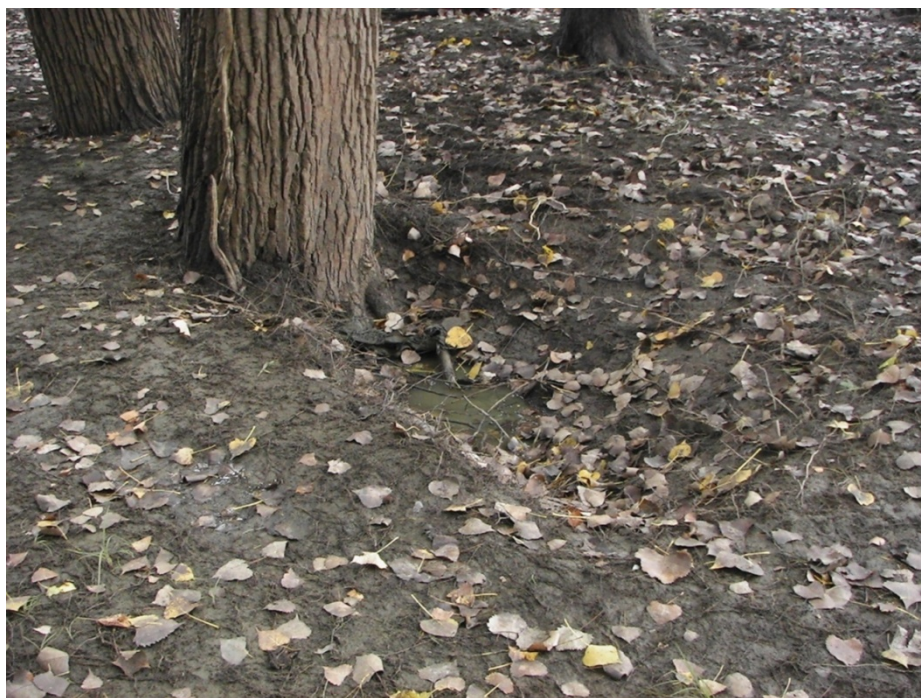
Scour hole around tree base.

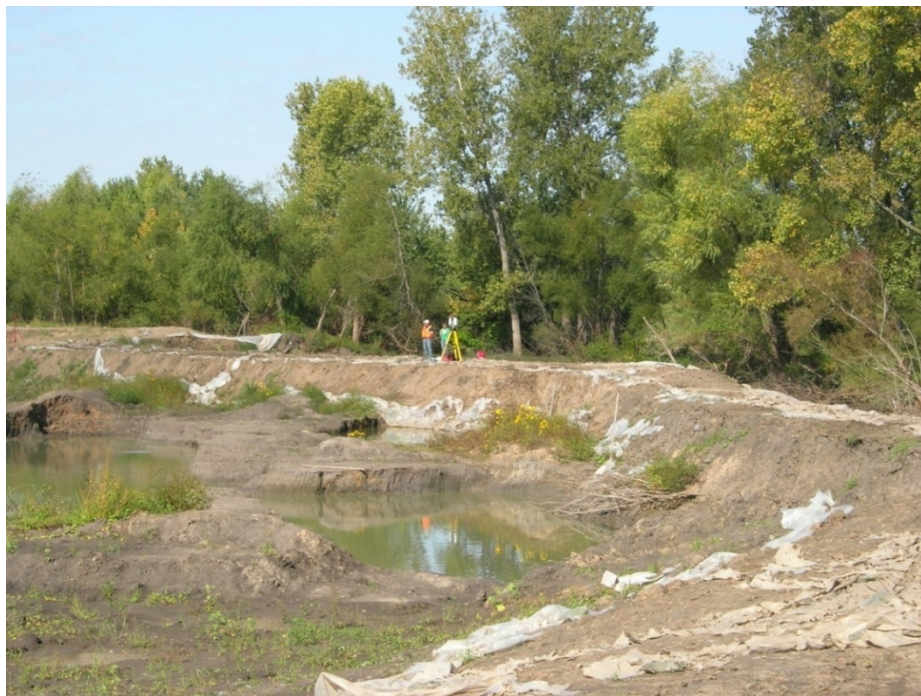
Breach area and temporary repaired levee looking West.

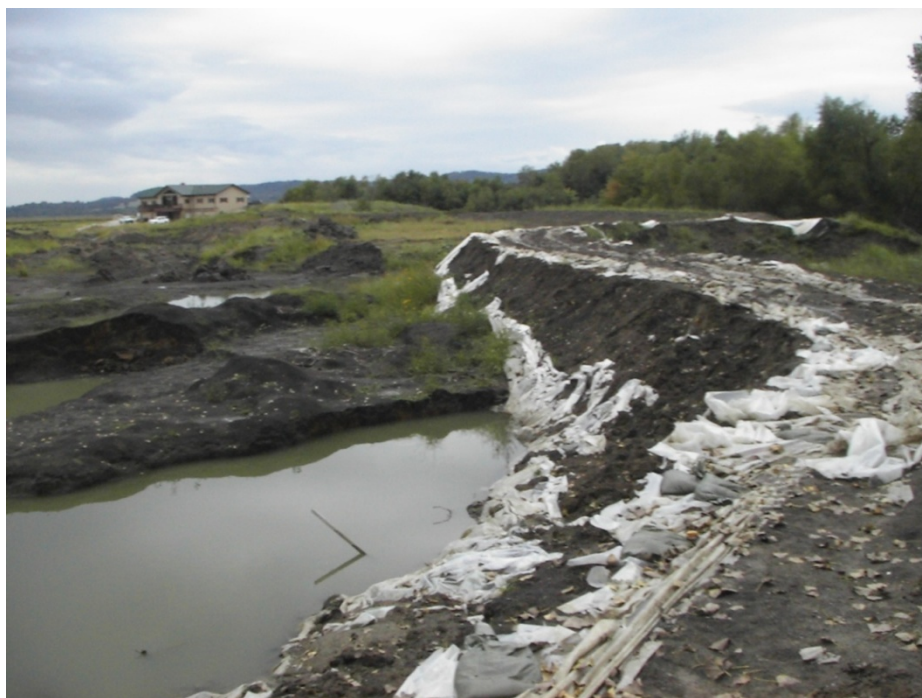
Temporary repaired levee and plastic sheeting.

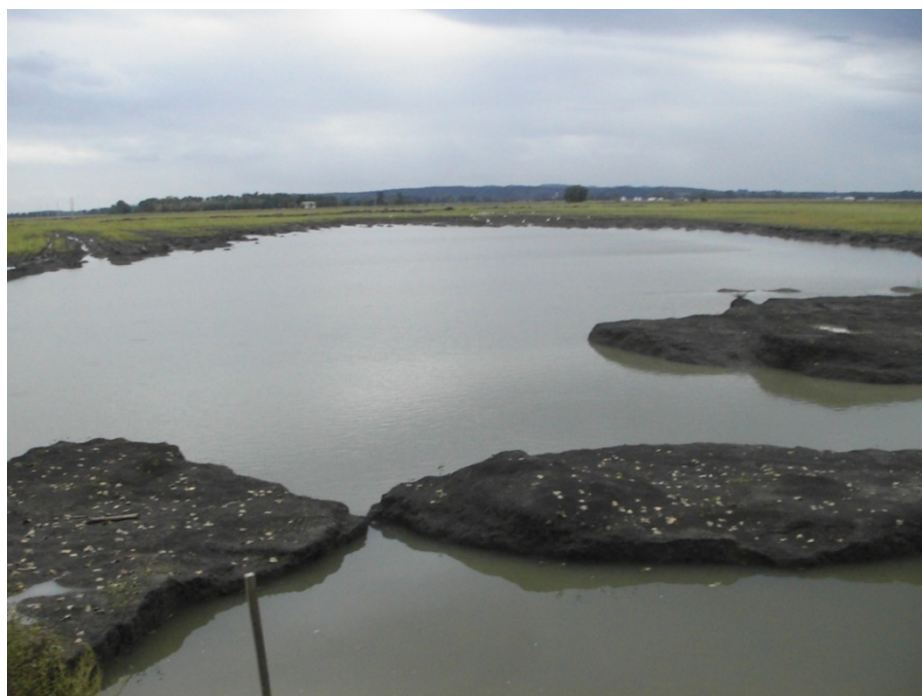
Scour Pool.

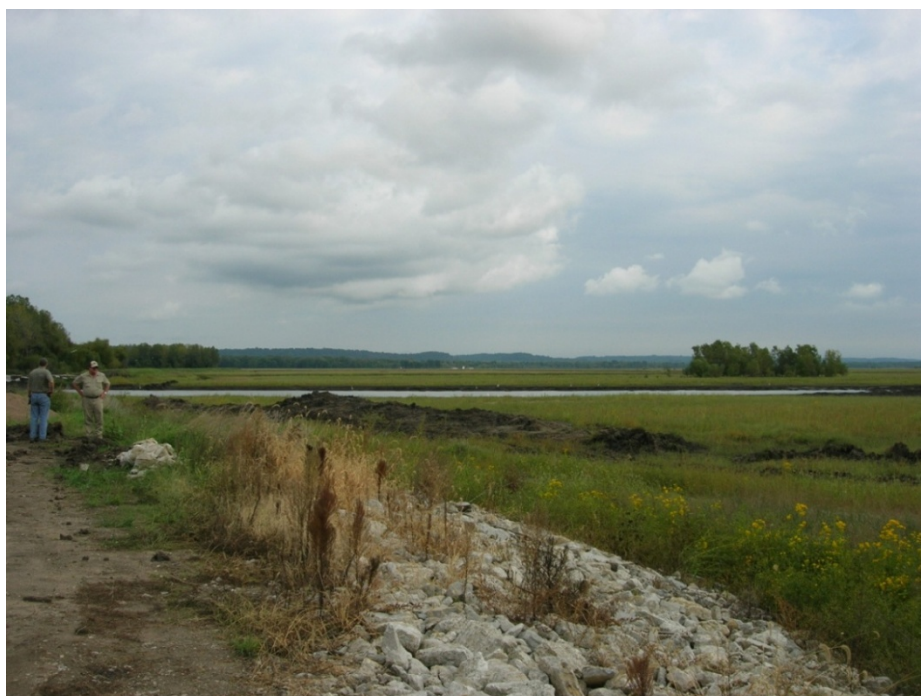
Section of temporary repaired levee which has been rocked.

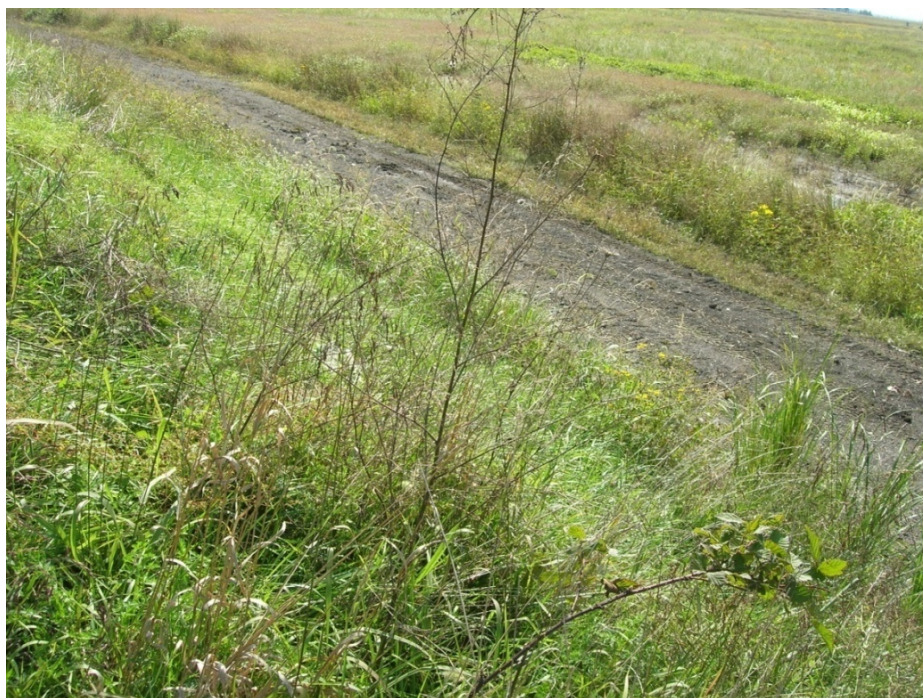
Levee side slope vegetative cover.

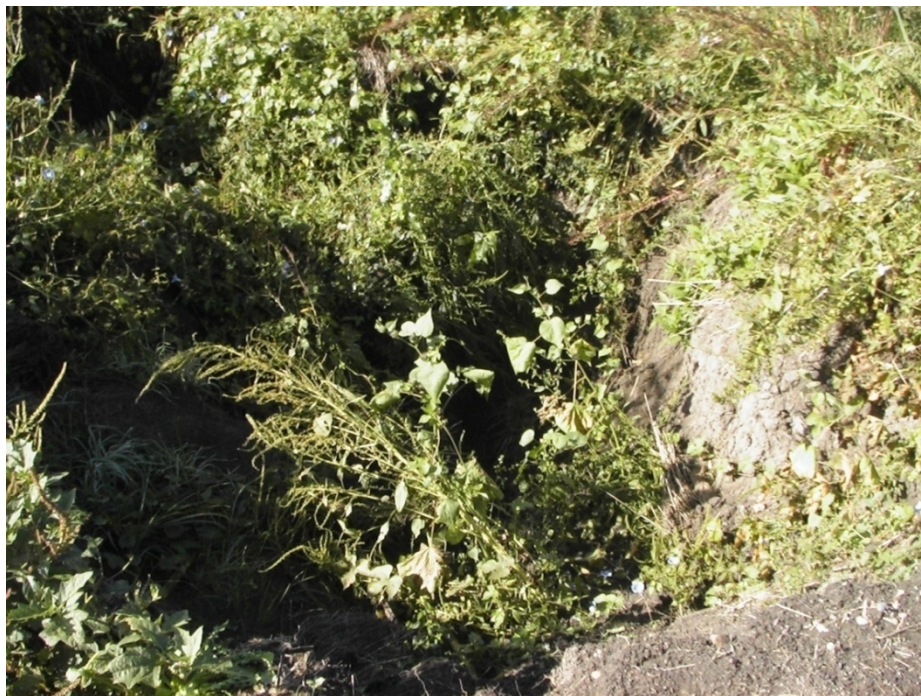
Scour hole.

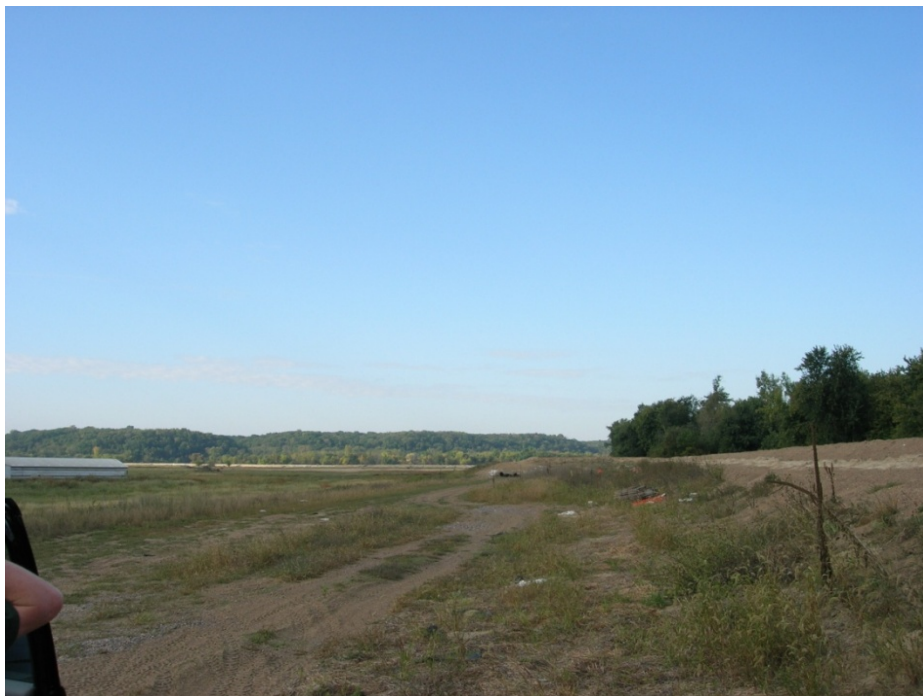
Sand shell/clay core levee system looking South.

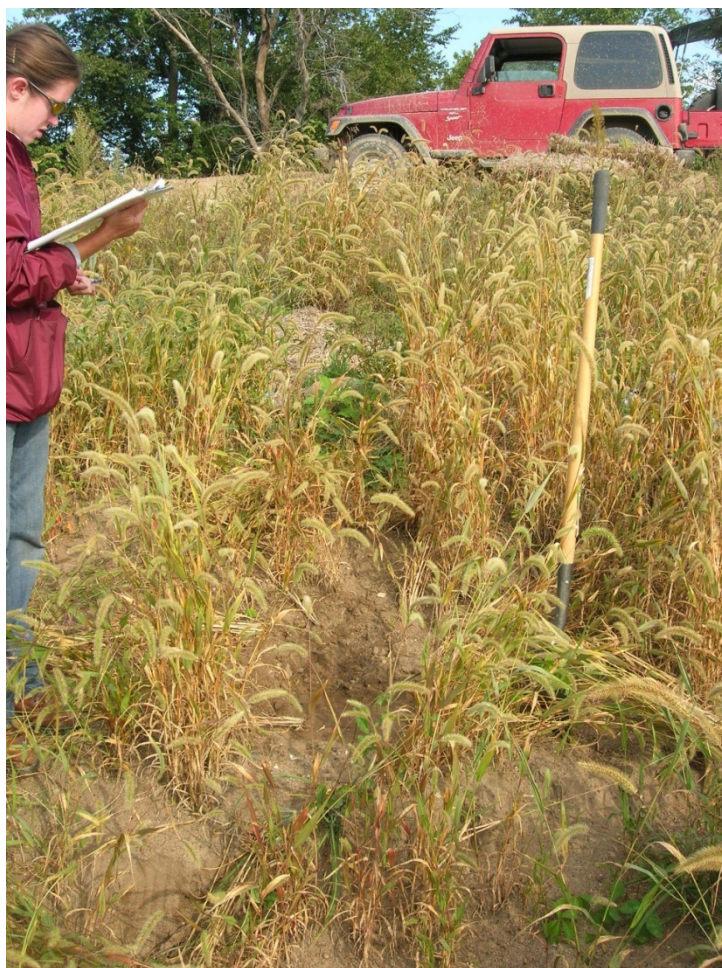
Foxtail found on the land side slope of remaining levee.
